Geological factors effecting slope instability in the Virginia Coastal Plain: Observations from the 2018 Nottoway Lane Rotational Landslides, King William County

VA Department of Mines, Minerals, and Energy
Division of Geology and Mineral Resources

April 18, 2019

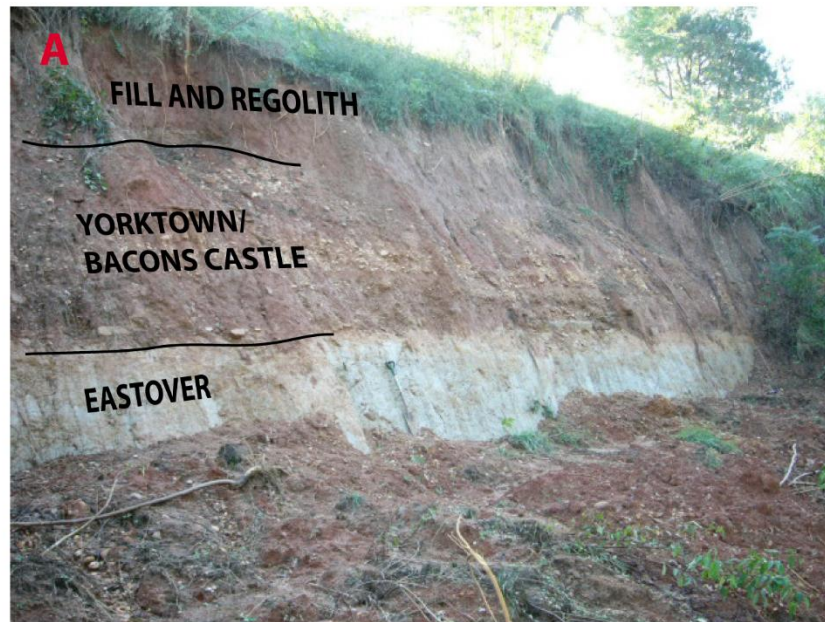
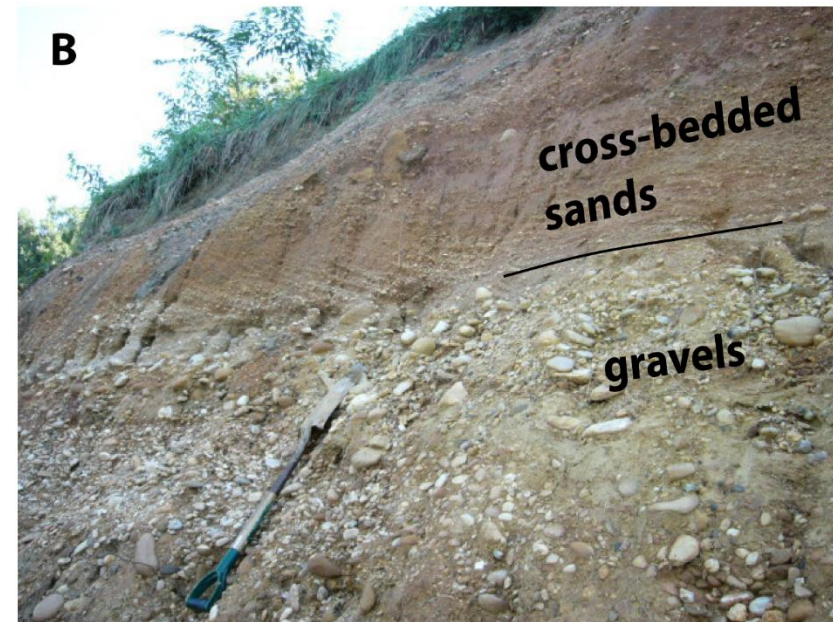
Figure 4: Photographs of the main scarp on the west slope of Chimborazo Hill. **A:** Photograph, looking southeast, of the fresh exposures of Yorktown/Bacons Castle Formations (sand and gravel layers) above Eastover marine clays in the main scarp. Photograph is from Location “G” in Figure 2. Shovel is approximately 3.5 feet long. **B:** Photograph, looking northeast, of the fresh exposures of Yorktown/Bacons Castle Formations (cross-bedded sand and gravel layers) in the main scarp. Eastover Formation crops out just below shovel handle. Photograph is from Location “I” in Figure 2.
